2019 Annual Report Storm Water Management Plan Carnegie State Vehicular Recreation Area

Off-Highway Motor Vehicle Recreation Division

Department of Parks and Recreation

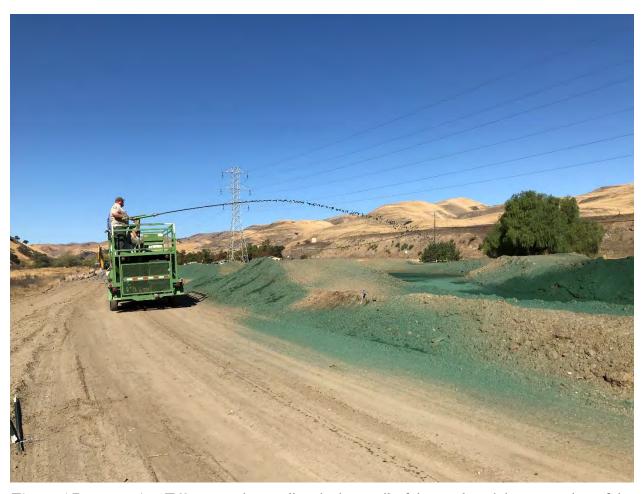
Figure 5 Revegetation Efforts: Hydro-seeding the bare soil of the quad track in preparation of the wet season

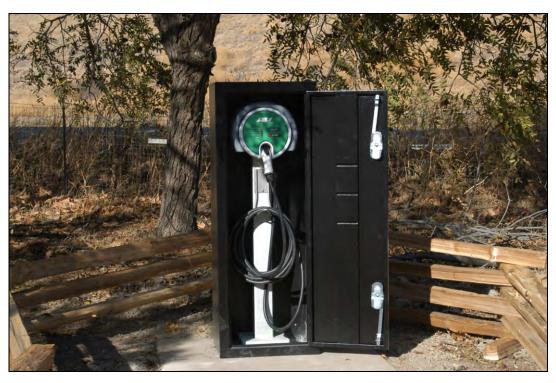
Figure 6. New charging station installed for use by electric dirt bikes.

Additionally, a charging station was installed to provide for the emerging electric motorcycle market and the riders that use them in the park.

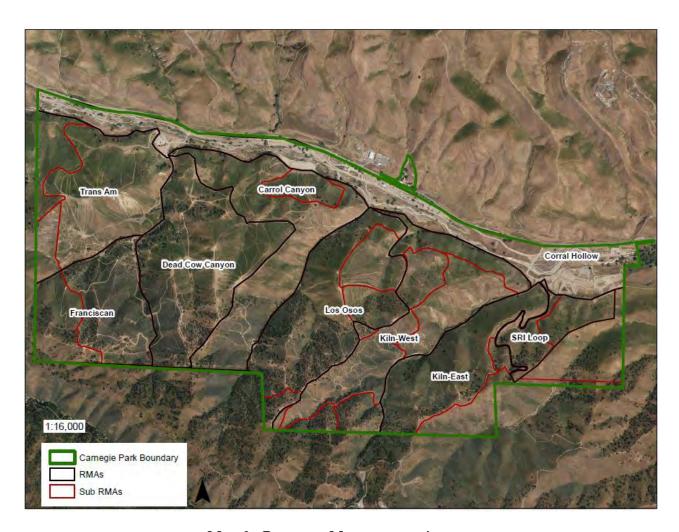
Map 3: Resource Management Areas.

Corral Hollow, SRI-Loop, and Kiln-East RMAs are completed and open as "trails-only". Portions of Kiln-West, Los Osos, and Trans Am RMAs are undergoing rehabilitation efforts.

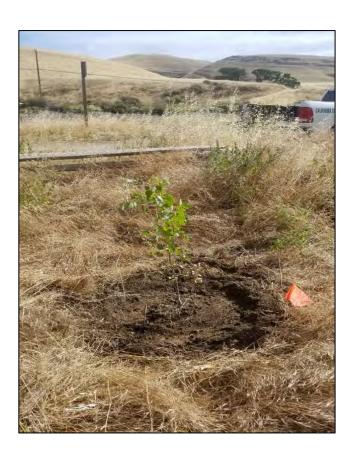
Figure 8: Corral Hollow Creek Floodplain Restoration. Tree planting done by staff; including Sycamore, Willow, and Mule Fat species.

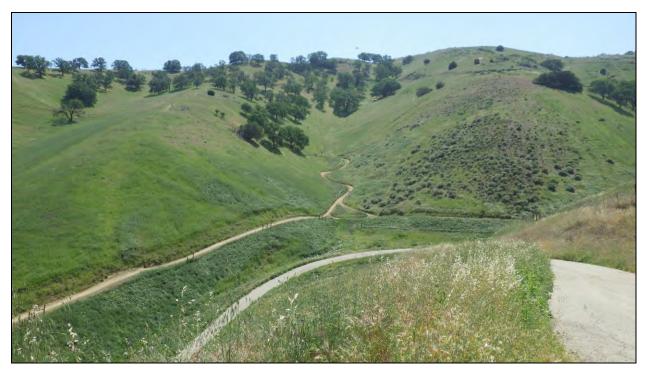
Figure 9: SRI Loop RMA. This was the first RMA in the hills and reopened in 2011. Off-trail riding has been minimalized and vegetation cover maintained through education, inspections, enforcement, and trail design (photo from April 2018).

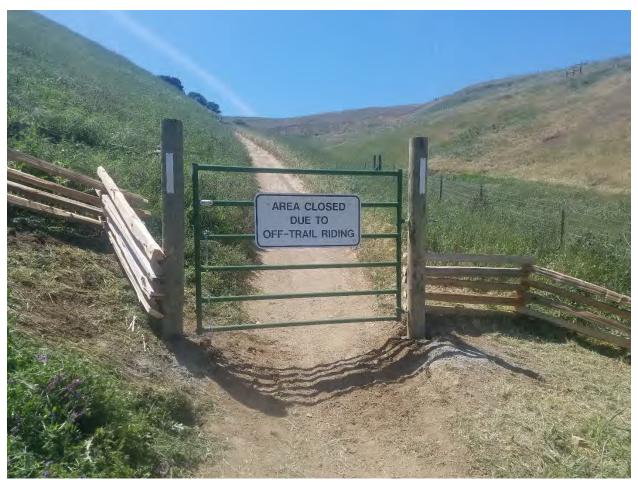
Figure 10: Signage Used to Communicate to Recreationalist the Purpose of the Closure.

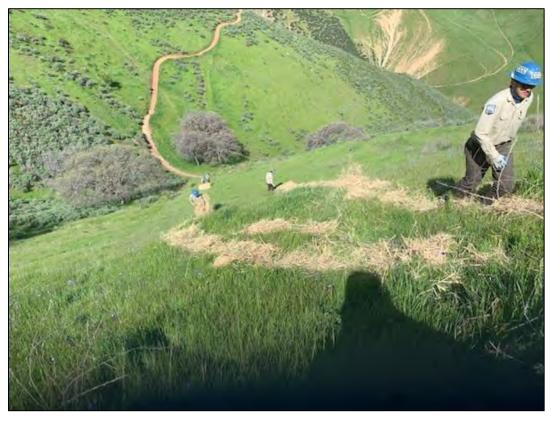
Figure 11: Off-trail route repair. CCC Members covers unauthorized trails with rice straw.

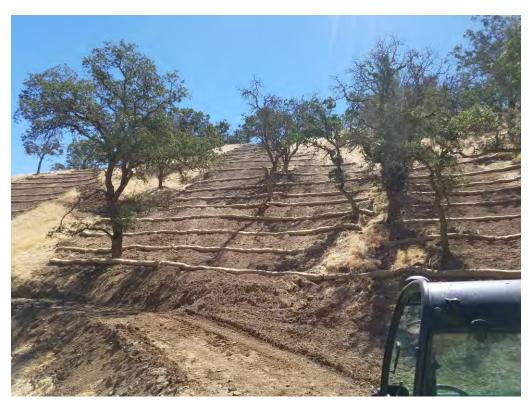
Figure 13: Wattle installation within Black Bear Sub-RMA.

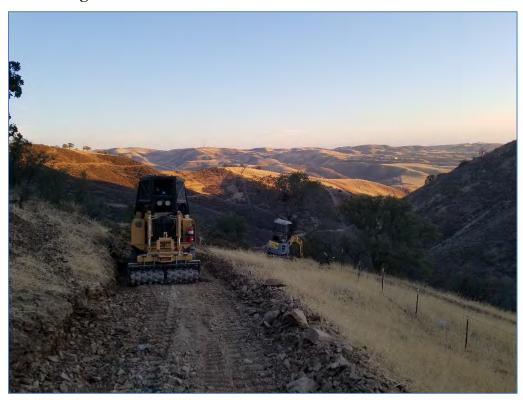
Figure 14: Trail Work within Black Bear Sub-RMA.

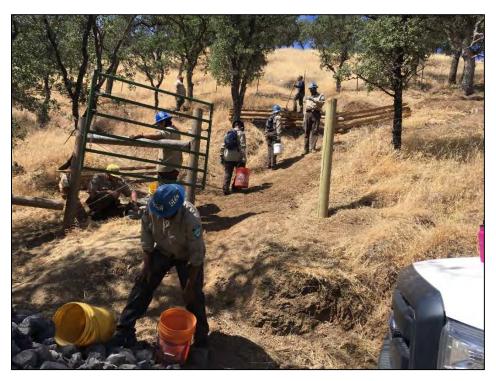
Figure 15 Staff and the CCCs hand-placing rock to prevent erosion on the side of a new trail in Black Bear Sub-RMA. (2018)

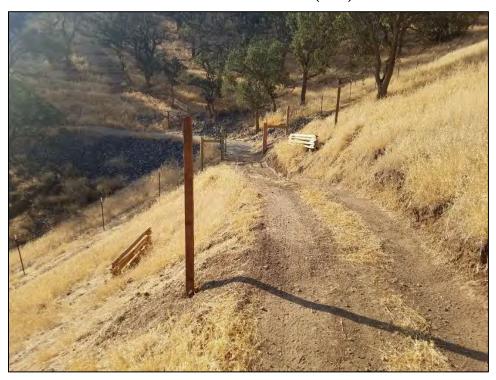
Figure 16: Example of new fencing installed in Black Bear RMA (July 2018)

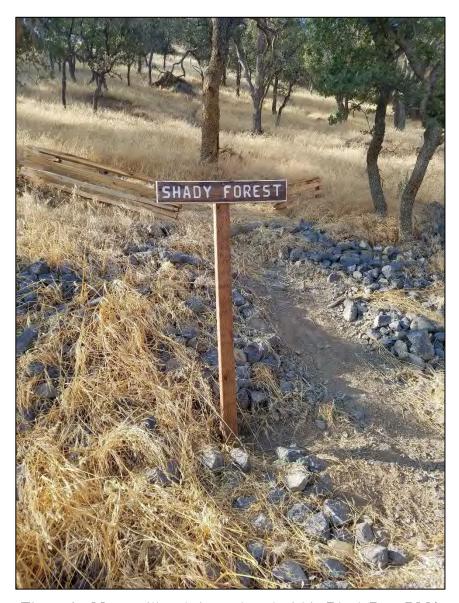
Figure 17: New trailhead signs placed within Black Bear RMA

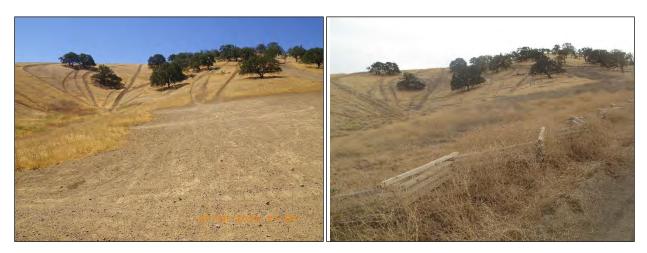
Figure 18: The Harrison Hill Sub-RMA, Before and After Rehabilitation. The left photo was taken in 2012. The area subsequently was closed and rehabbed. The right photo was taken 2017 after rehabilitation efforts were completed and the area reopened.

The focus within this RMA then turned to the Sub-RMAs of Harrison Hill and Los Osos Climb. The Harrison Hill area (21 acres) was an open riding area that had numerous vertical trails and an erosional feature in the drainage. The area was closed, re-contoured, wattles installed, and hydromulch applied. Once the vegetation became established, the CAT assisted with designing trails that were aimed at providing recreational opportunity for both All-Terrain Vehicles (ATV) and motorcycles. The area reopened to recreation in May 2016 and the new trails make up approximately 2.7 percent of the area.

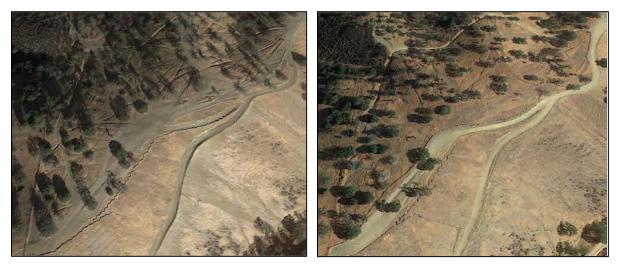
Figure 19: Phase 3 Sub-RMA. The aerial on the left shows the area prior to rehabilitation (Oct. 2015) and the photo on the right is from June 2018 after work was completed.

Another smaller Sub-RMA, Phase 3, was also opened this reporting cycle (Figure 19). This area is approximately 8.5 acres and prior to rehab efforts had 1.52 miles of inventoried trails (as stored in the park's trail database). A perimeter fence was installed, and a sustainable trail route will be designed and reestablished.

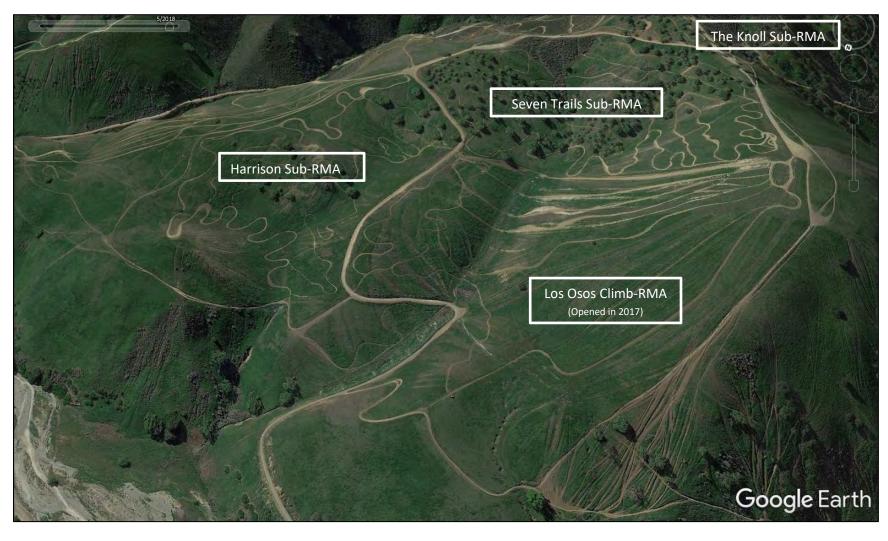
Figure 20: Los Osos RMA, April 2018. Several Sub-RMAs are visible in this screenshot. The trails have been reduced in this area by converting from an open-riding to a trails-only system. Source: Google Earth 2020.

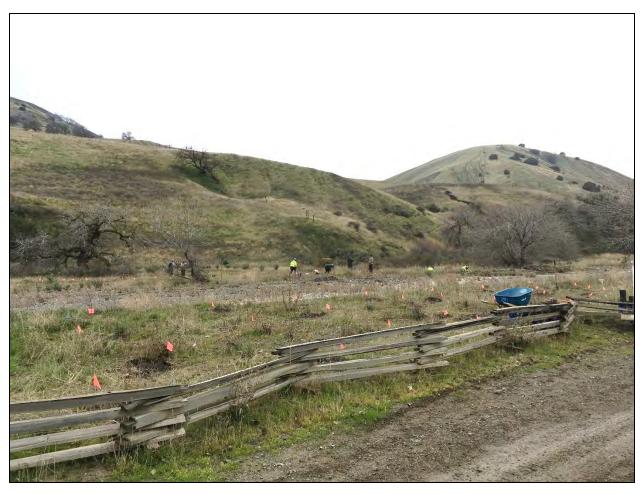
Figure 21: Staff and CCCs Planting Native Riparian Vegetation. Approximately 850 native riparian trees were planted in Corral Hollow Creek during the 2018/2019 winter

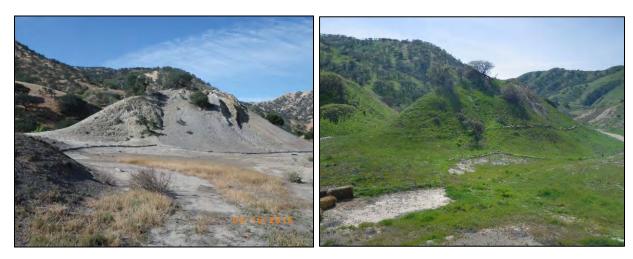
Figure 22: Mine Tailings Before and After Compost and Native Seed Application. The photo on the left was taken in 2015 and the photo on the right is from 2017 following the compost and seed applied in the fall of 2016.

The Tesla Mine Complex (122 acres) current condition consists of historic industrial mine sites including disturbed soils, tailing piles, adits/mine shafts, and the remnants of towns constructed to support the former mining activities. The site no longer has mining activities and is closed to the public. In order to limit erosion on site, several temporary BMPs have been installed over the last several years including gravel bag check dams and silt fences. This reporting cycle portions of the tailing's piles were covered with compost and hydro-mulch. The compost application that was implemented in late 2013 continued to support vegetation even after a fire had burned portions of the composted area. An additional 1.42 acres of tailing was covered in compost this reporting cycle. In addition, approximately 600 feet of silt fence was installed to help capture sediment from entering the creek. Longer term BMPs are still being evaluated and scoped.
